Remediating and Monitoring White Phosphorus Contamination at Eagle River Flats (Operable Unit C), Fort Richardson, Alaska

FY07 Data Report

Susan R. Bigl and Charles M. Collins, Report Editors

May 2008

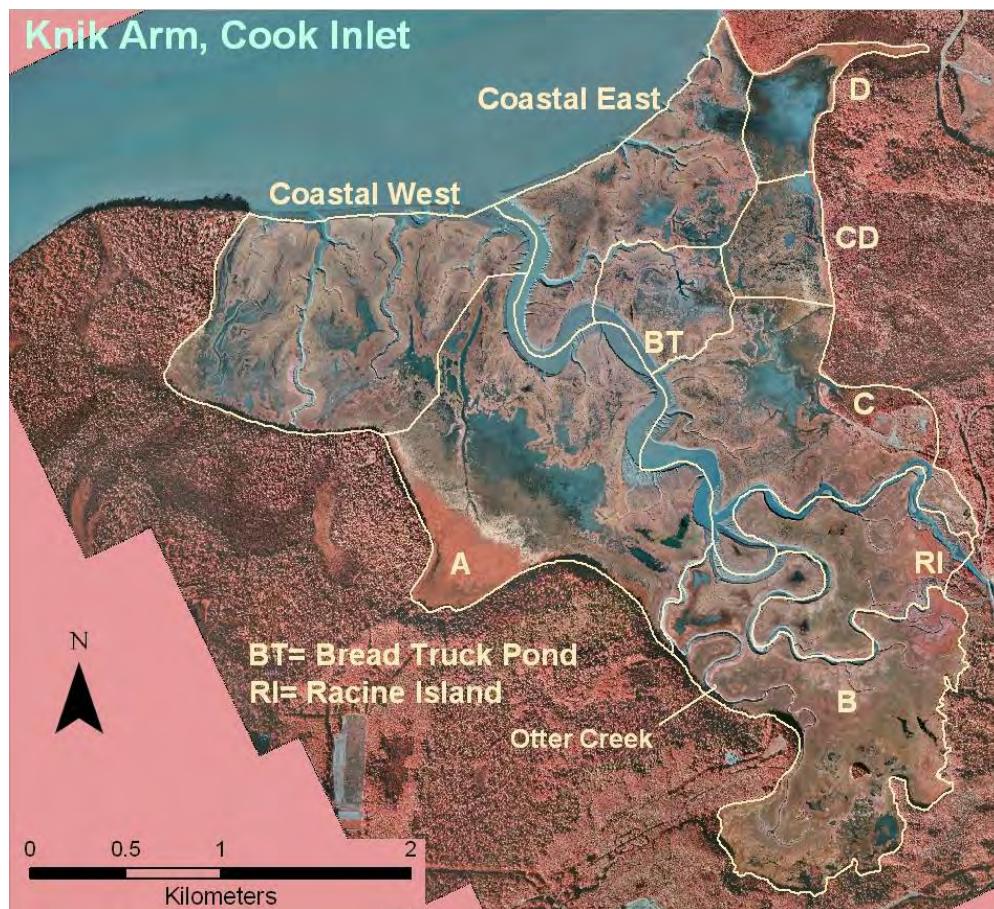
Figure II-1-1. ERF study area with standardized survey areas, ponds, sloughs and Eagle River.

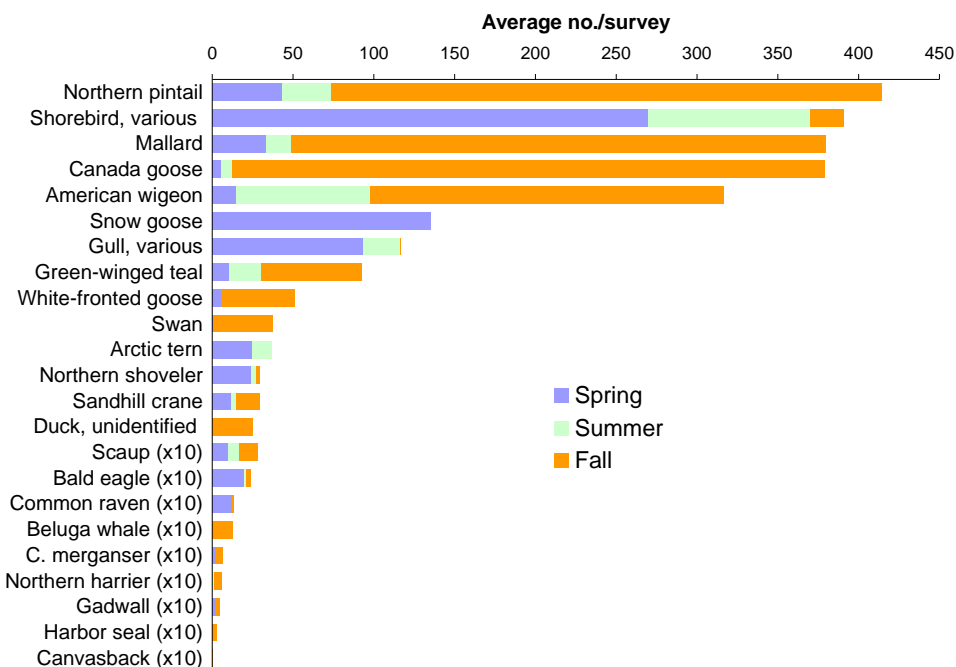
Figure II-1-2. Relative abundance of all species or species groups counted during ERF aerial surveys in 2007. Listed in order of yearly abundance. Bars of less common species represent numbers of individuals multiplied by 10.

Species composition and abundance for all birds and wildlife surveyed in 2007 was similar to past years (Fig. II-1-2; Appendix II-1-B).

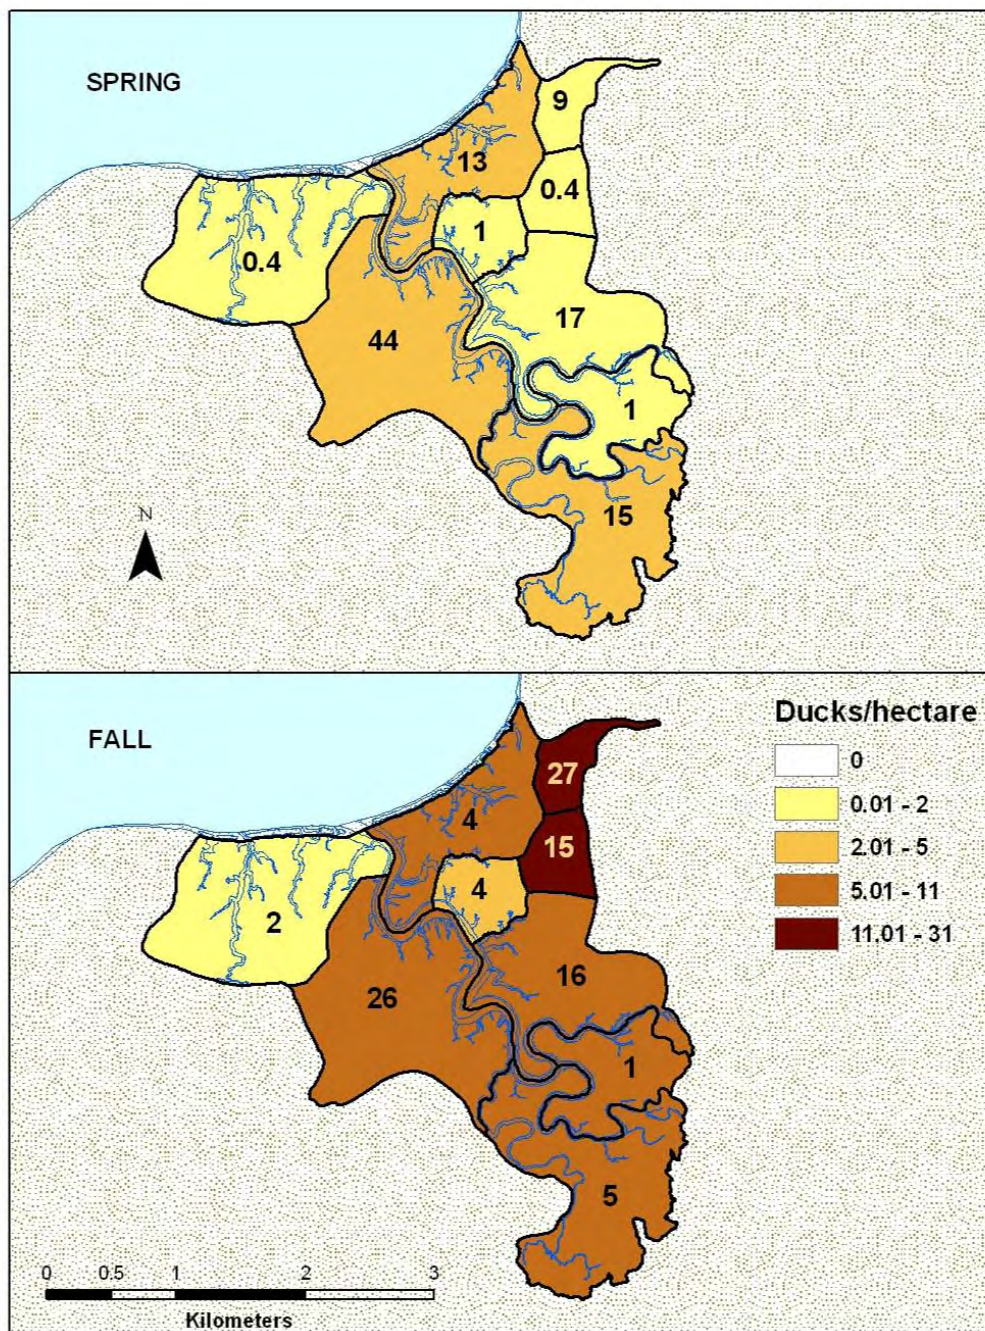
Figure II-1-5. Mean densities of ducks on ERF study areas in spring and fall 2007. Numbers within areas are the percent total ducks observed in each area. The area (ha) of permanent and intermittent ponds in each area was used to calculate densities.

In spring, the number of ducks peaked on 11 May (8 May, in 2006) and duck use of ERF was generally light. Areas A, B and C had the highest densities and numbers of ducks in spring (Fig. II-1-5, Appendix II-1-C). Unlike 2006, rainfall was low in the Anchorage area and Upper Cook Inlet area in 2007, possibly resulting in poor habitat conditions for ducks relative to 2006. As a result, fewer ducks were observed in spring and summer.

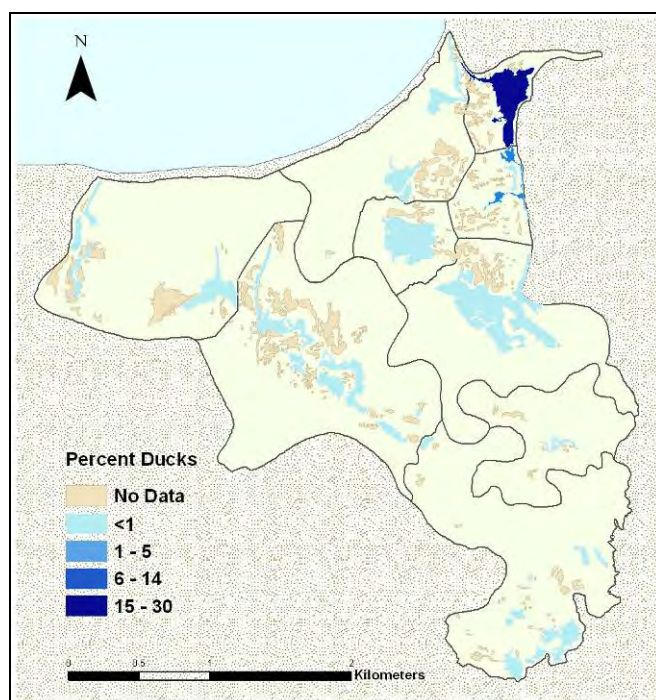
Figure II-1-6. Percent use of ponds by ducks in fall 2007. Data are for duck observations classified to pond numbers. A majority (96 %) of duck observations in ponds were in ponds identified by pond number.

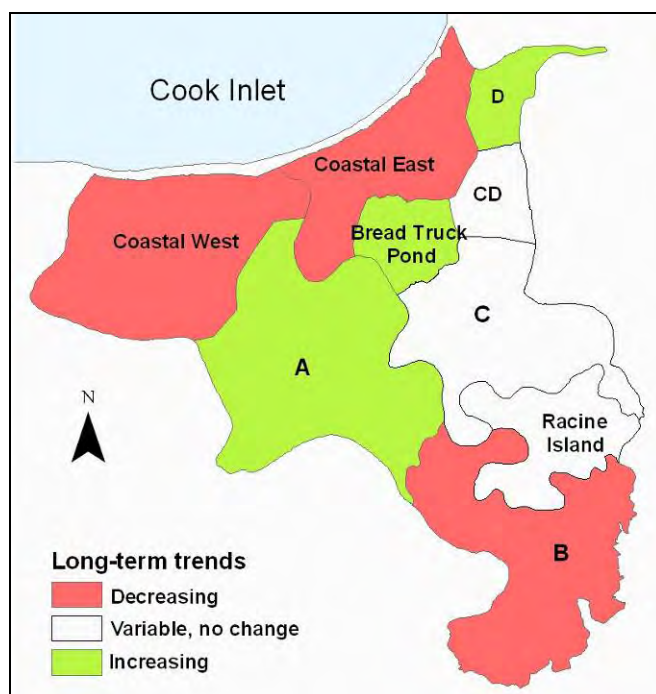
Figure II-I-7. Standardized areas of ERF showing trends of duck use for fall 1997-2007 aerial surveys.

Duck use between study areas has changed from 1997 due to ongoing treatability studies, a rotation of pond remediation and other efforts to reduce exposure of ducks to white phosphorus (Fig. II-1-7, Appendix II-1-D, E). Of the four major habitat types used to classify duck locations (ponds, river, slough and shoreline), ponds, as expected, were by far the most important in 2007. Use of ponds over other habitat types by ducks has become even more apparent in recent years. Most significantly, use of Areas A and D in 2007 continued to show an increase in relative fall abundance of ducks over the past few years and the use of ponds in areas B and Coastal West continued to decline from earlier years.

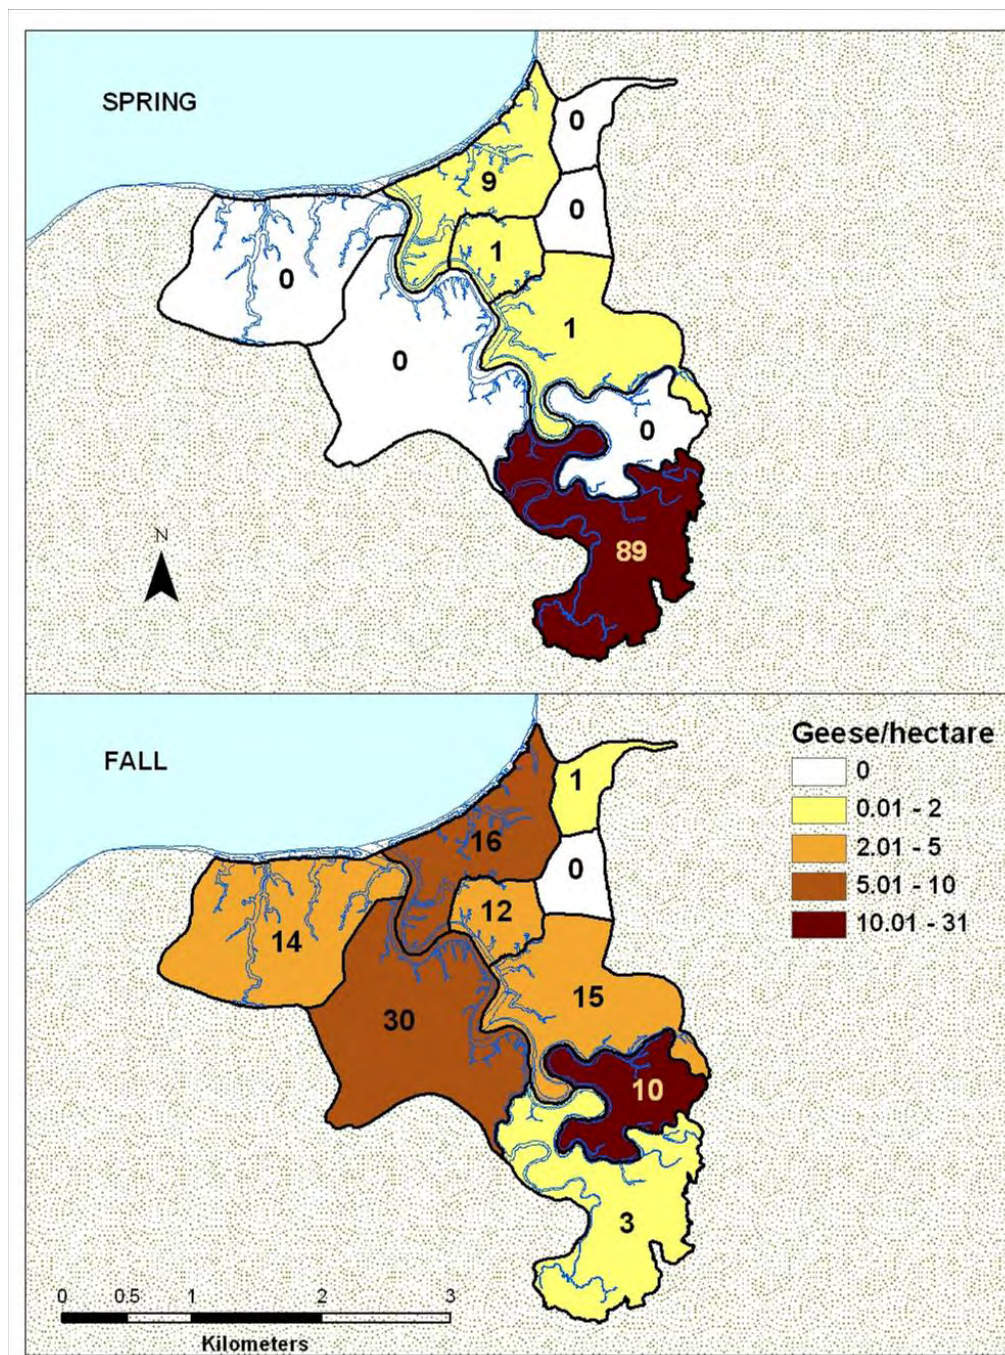
Figure II-1-8. Mean densities of geese on ERF study areas in spring and fall 2007. Numbers within areas are the percent of total geese observed in each area. A large flock of snow geese accounted for 96% of spring Area B birds. The area (ha) of permanent and intermittent ponds in each area was used to calculate densities.

Fall goose migration was similar to other years; though the influx of geese was earlier, with a count of 910 on 24 August. Peak use (count of 1369) occurred in early September, with 82% Canada geese and the remainder greater white-fronted geese. Tule white-fronted geese were more consistently present and in greater numbers in ERF than in fall 2006. Snow geese generally do not migrate through Cook Inlet in fall and were not observed in ERF in fall 2007. As in the past, the heaviest use by geese occurred in Area A, Coastal West and Coastal East, but also in several other locales (Fig. II-1-8, Appendix II-1-A).

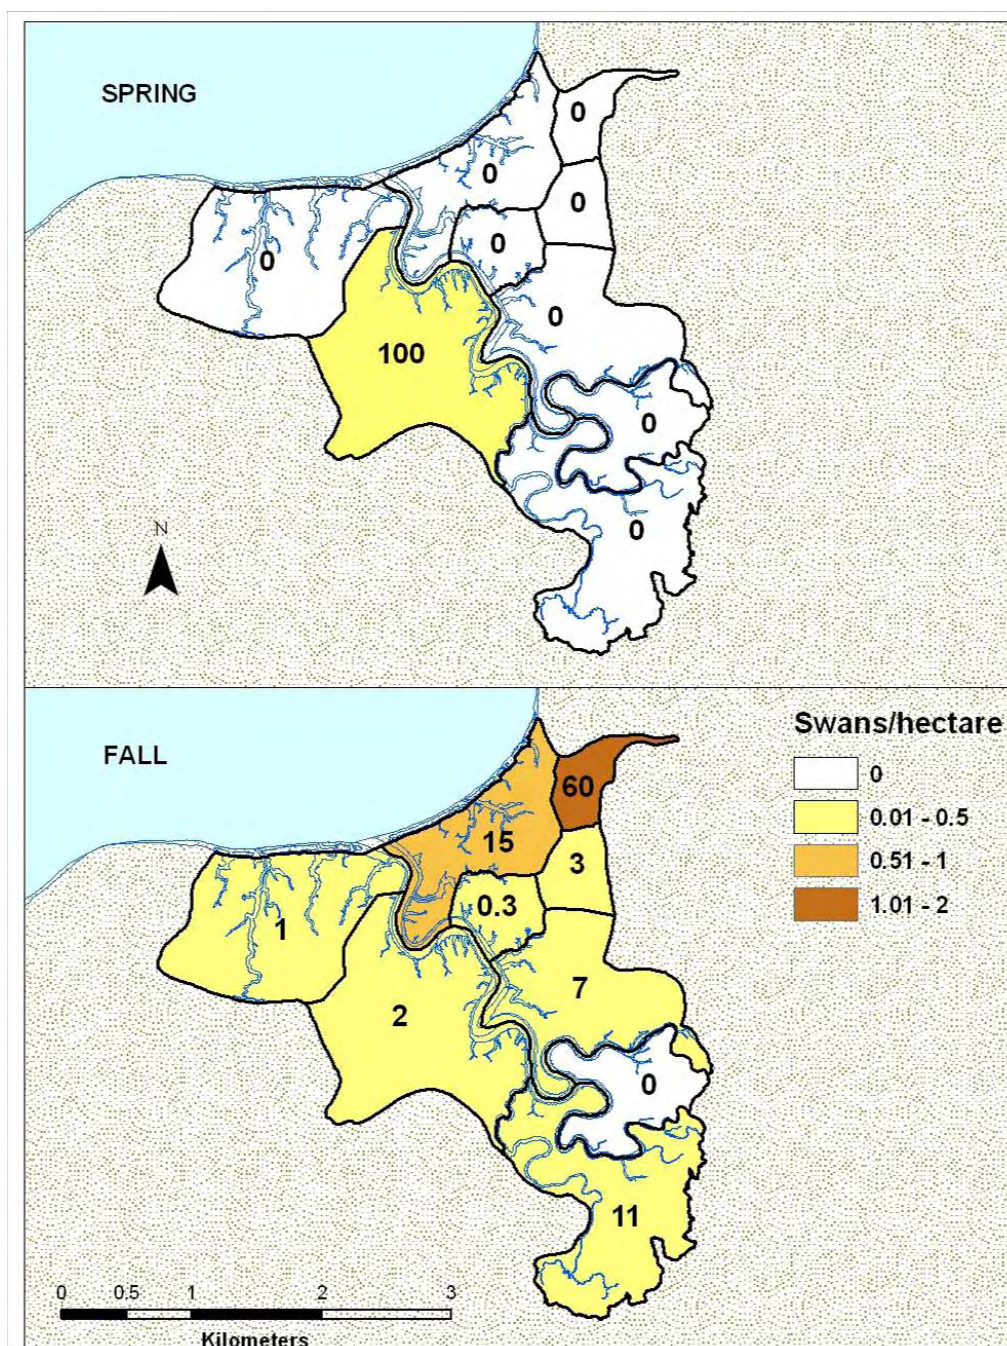
Figure II-1-9. Mean densities of swans on ERF study areas in spring and fall 2007. Numbers within areas are the percent of total swans observed in each area. The area (ha) of permanent and intermittent ponds in each area was used to calculate densities.

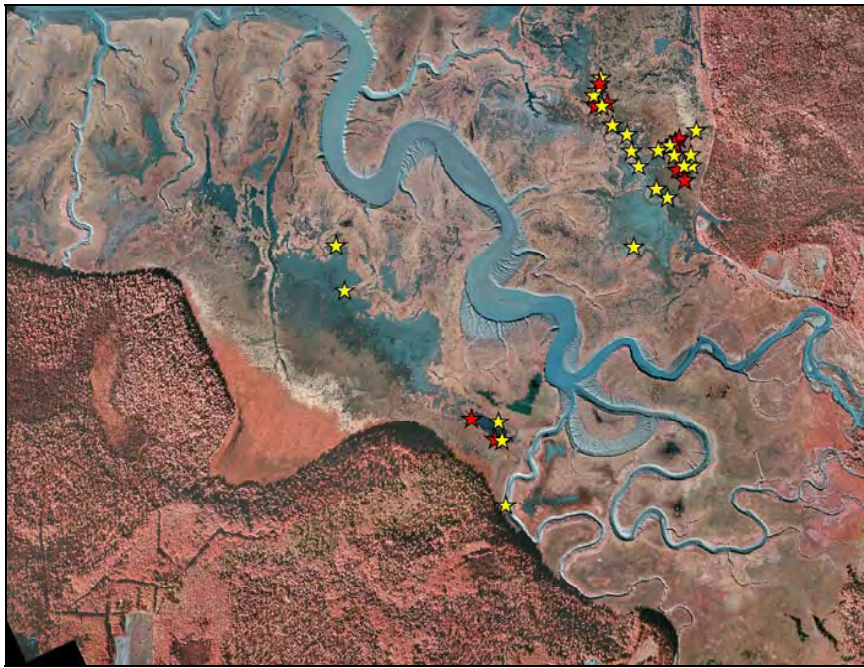
Figure II-2-2. Locations of 2007 duck mortalities in Eagle River Flats. Carcasses shown as red stars and feather piles by yellow stars.

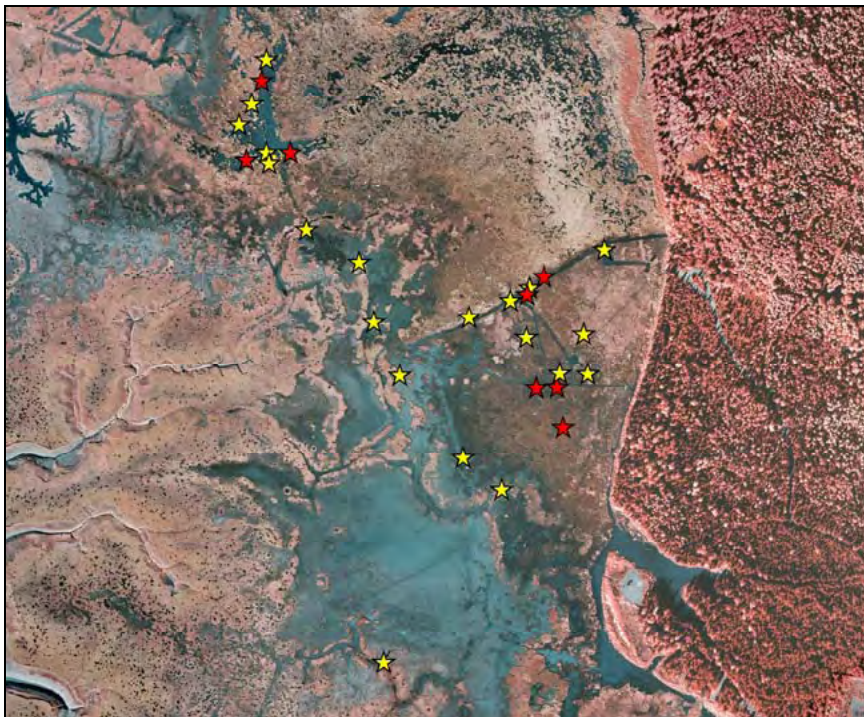
Figure II-2-3. Locations of 2007 duck mortalities in Areas C and C/D. Carcasses shown as red stars and feather piles by yellow stars.

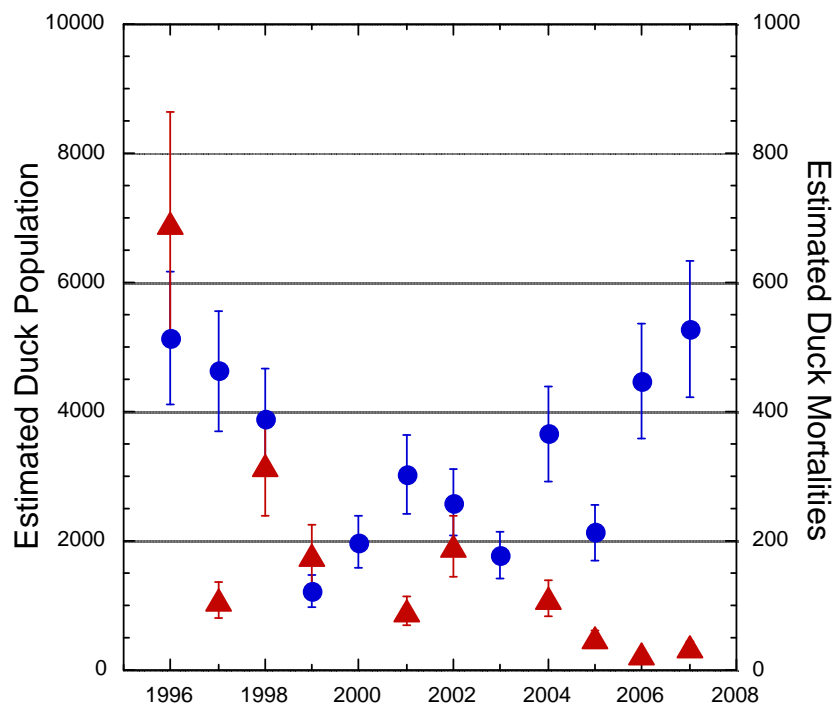
Figure II-2-4. Estimated fall dabbling duck population (dots) plus estimated number of duck mortalities (triangles). Duck mortalities from 1996—2002 were determined from NWRC telemetry studies. Mortality data are missing for 2000 and 2003 when telemetry studies were not conducted. Mortalities from 2004 through 2007 are from the ground-based transect surveys.

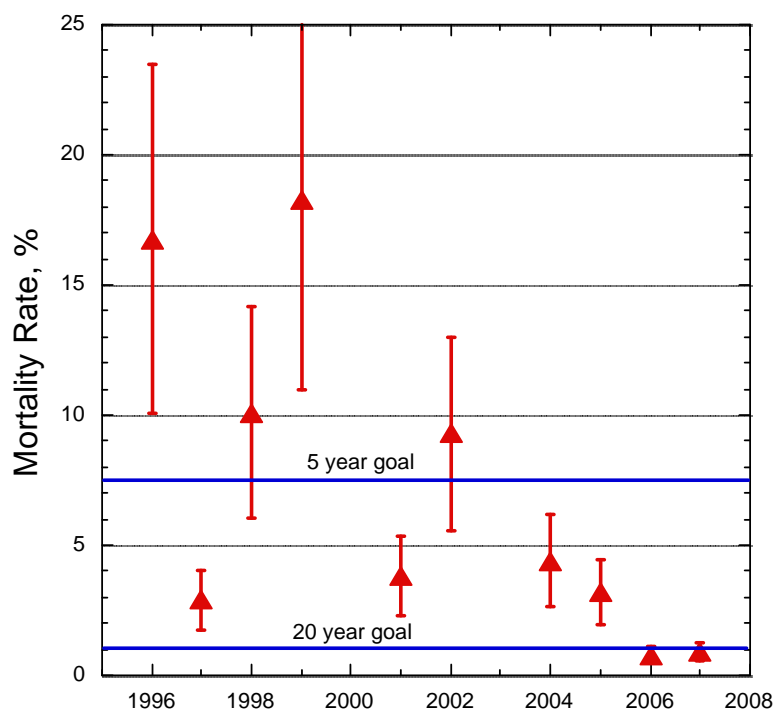
Figure II-2-5. Plot of estimated duck mortality rate as a percentage of fall Eagle River Flats dabbling duck population from 1996 – 2007. Included are the estimated mortality rates from 1996 – 2002 determined with NWRC waterfowl telemetry studies and the 2004 – 2007 mortality rates determined from the ground-based mortality surveys. Missing are data for 2000 and 2003 when waterfowl telemetry data were not collected.

Figure II-2-5 plots mortality rate as a percentage of the total fall dabbling duck population from 1996 through 2007. Again, error bars for the 1996-2007 data may be larger than shown. Also shown are the five-year short-term and 20-year long-term remediation goals. The downward trend in mortality rates is pronounced with the long-term remedial action goal of less than 1% mortality of the fall dabbling duck population being met in each of the last two years. This reflects the tremendous amount of remediation that has occurred over the last ten years. In order to truly determine if the 20-year remedial action goal of 1% mortality rate has been met, annual monitoring of mortality should continue for the next several years. The exact amount of mortality monitoring that will take place will be determined as the Long-Term Monitoring Plan is developed over the next few months.

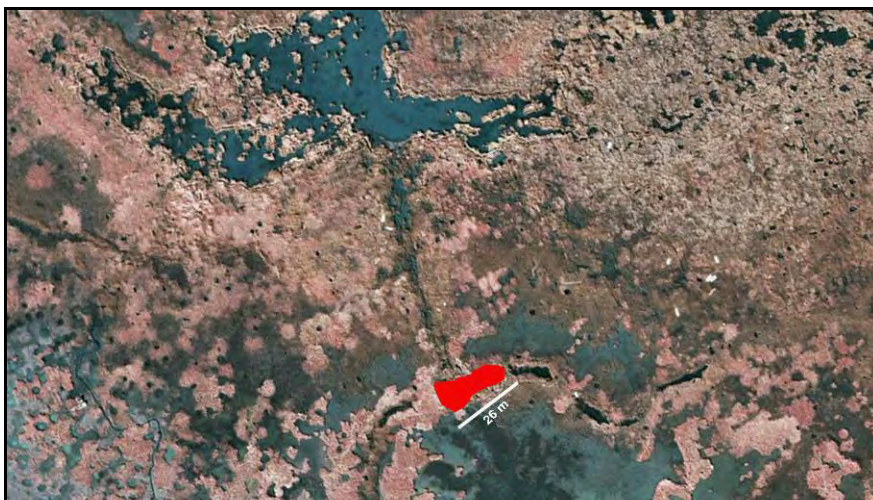
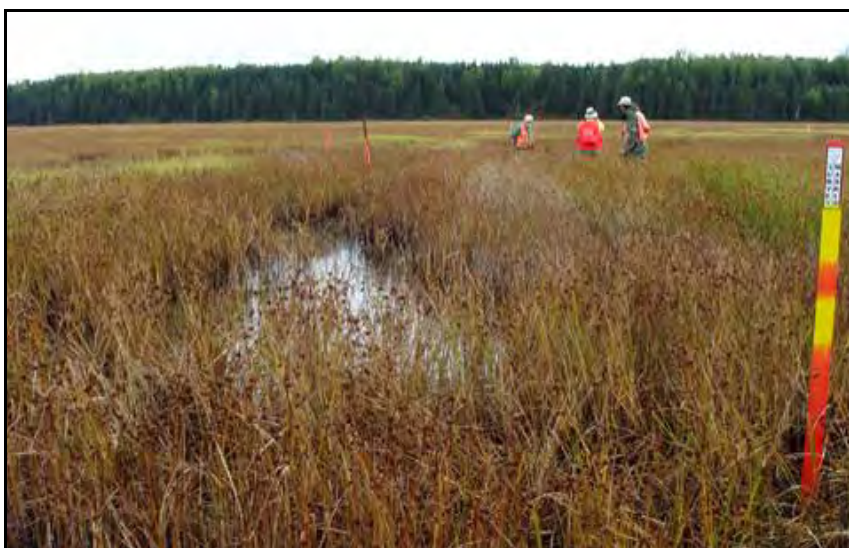
Figure III-1-2. Pond 23 prior to capping test.

a. Aerial view of Pond 23. Pond 730 is to the northwest.

b. Ground view of Pond 23 with marker stakes in place.

During the 2006 fall deployment, Pond 23 located in a marshy area between the Duck Ponds and Pond 730 was marked with large orange survey markers for future identification during treatment (Figure III-1-2). In March, after UXO clearance was completed, a 2-yard front-end loader was used to clear the roads, access to a gravel pile on the EOD pad, and the test site. A plow truck followed

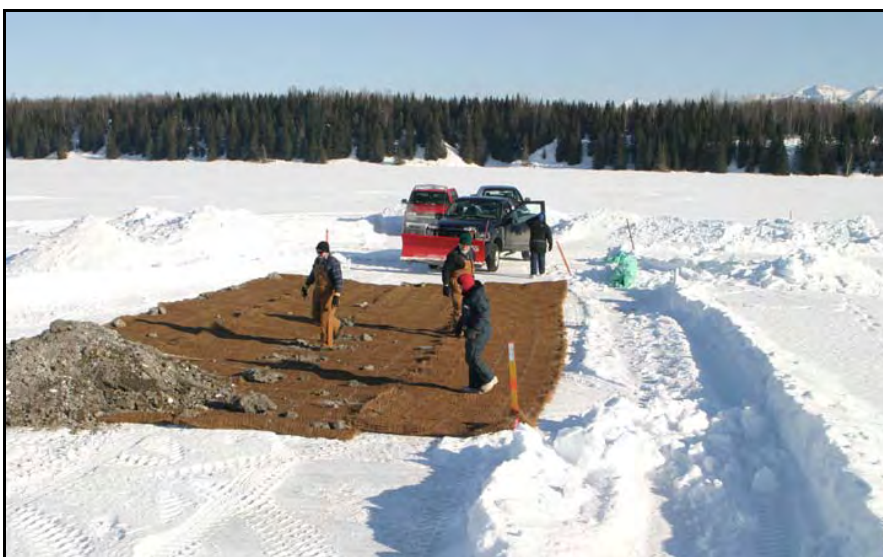
a. Laying out geotextile mat at test site. Note survey markers.

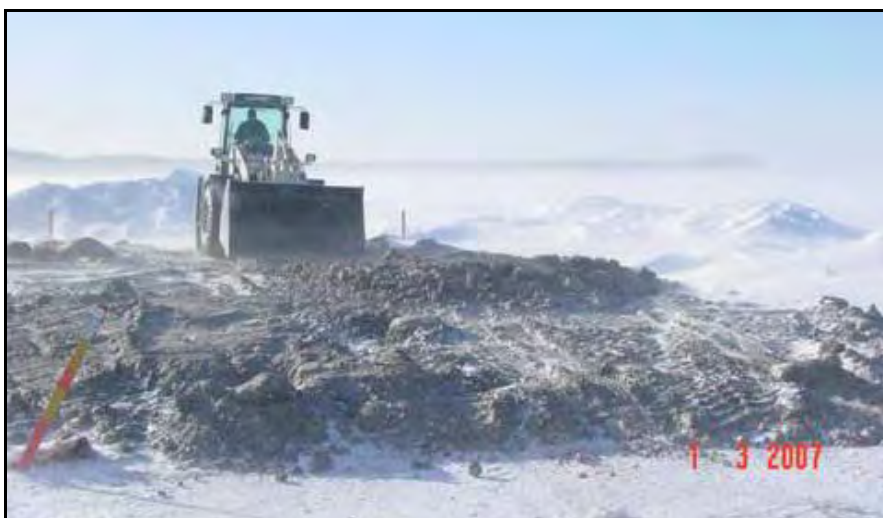
b. Spreading last load of gravel. Wind and drifting snow are evident.

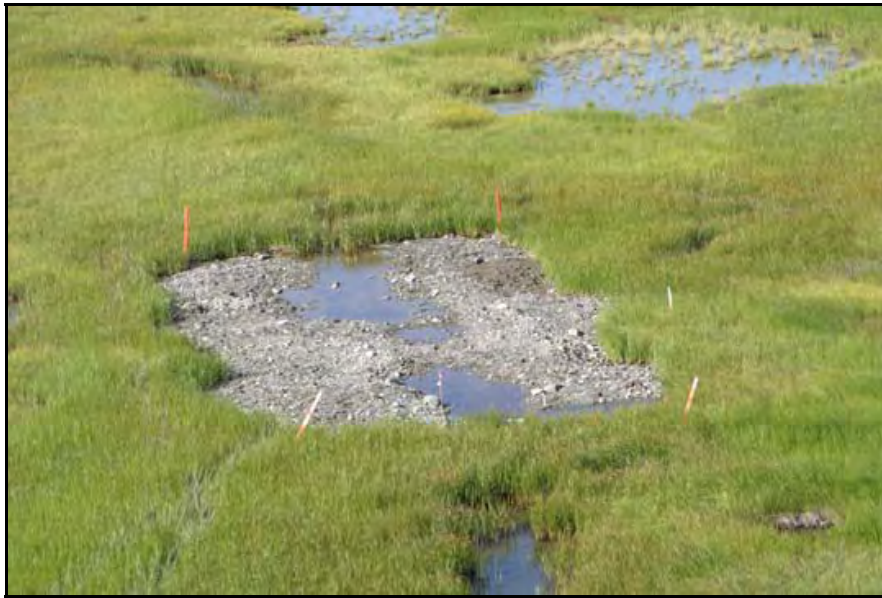
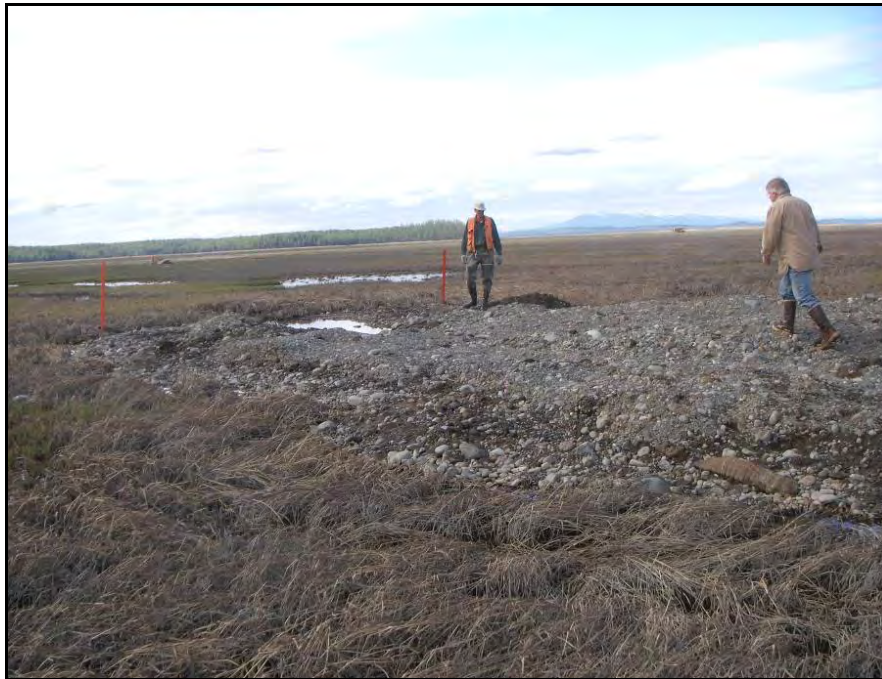
a. Aerial view in Fall looking west.

b. View from ground level looking northwest (Spring).
Figure III-1-4. Capped pond following the first winter.

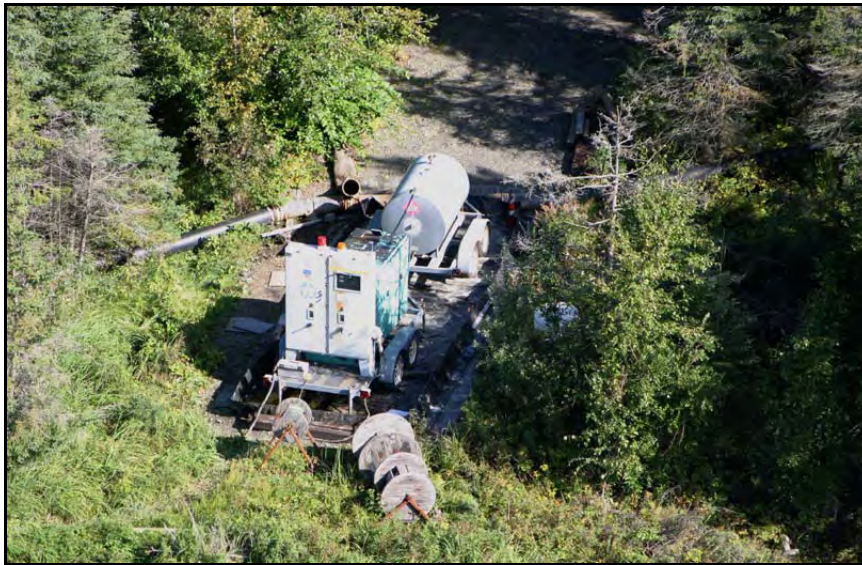
a. System 3, off the EOD Pad.

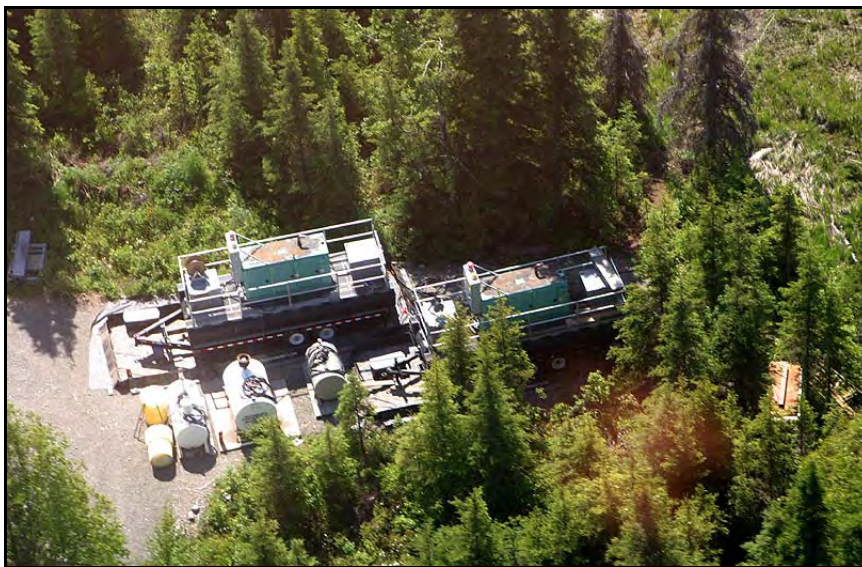
b. Systems 4 and 5 on the BC Pad.

To address the Bangalore ditches and locally-contaminated areas in C-Marsh, two pumps (Systems 4 and 5) were installed in sumps located within the ditch system. These are 126 L/s (2000 gpm) pump systems with shore-based trailer-mounted generators located at the Bomb Crater Pad east of C-Marsh. The pumps were located in the Bomb Crater sump (#4) and the South sump (#5). The 20-cm discharge lines were tied together in a “Y” north of the north Bangalore ditch, connecting with a 25-cm line that led to a gully draining into the Eagle River.

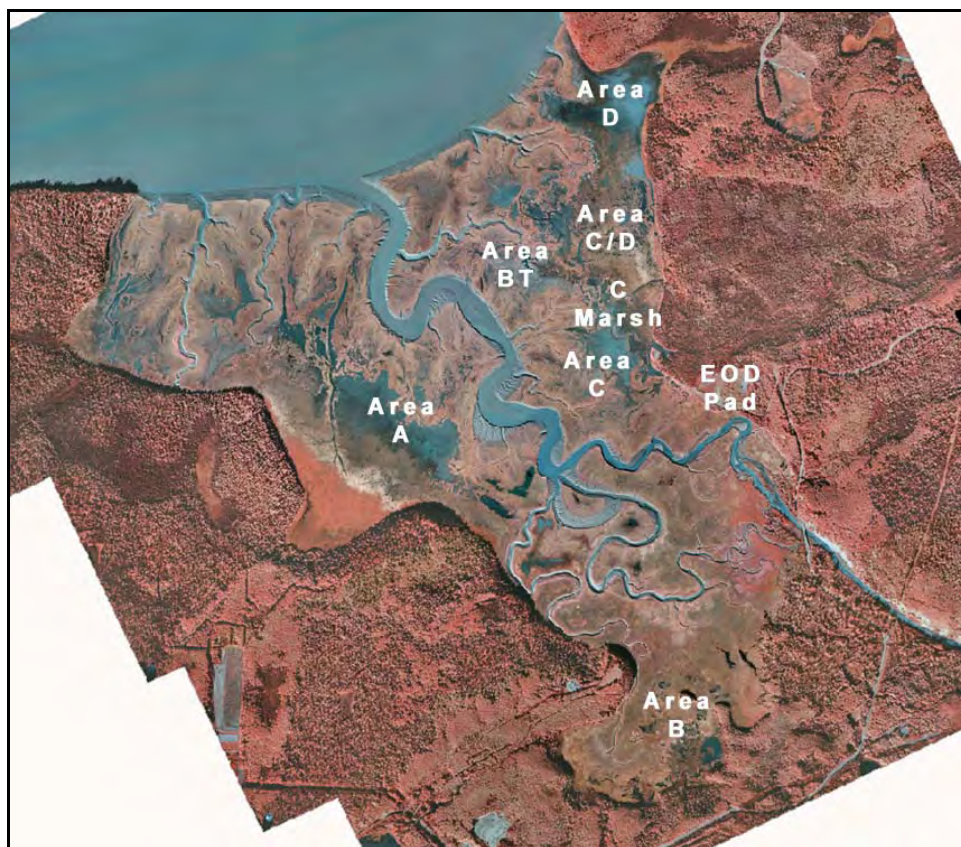
Figure III-2-1. Aerial photo of ERF (Aero-Metric September 2006) annotated with the standard area designations. Most residual white phosphorus resides in Area C Marsh.

In 2003 we found that high concentrations of white phosphorus were generally co-located with metallic remnants of detonated WP ordnance items such as mortar tail assemblies. In 2004 we performed a systematic magnetometer survey of the Area C Marsh (Fig. III-2-1) and the southeast section of Area BT to locate potential hotspots (localized areas of very high white phosphorus concentration). Between 2003 and 2004 we found 81 locations with WP and ordnance scrap. Additional surveys in 2005 and 2006 revealed three more hotspots. In May 2007 we resampled 77 previously identified hotspots (Fig. III-2-2), plus six new locations where metallic scrap was found. To locate the sample positions in the field, we navigated with a Trimble GPS Pathfinder Pro XR system to the selected UTM coordinates and used the site markers that remained from previous sampling. At each location, at least 20 increments of surface sediment were collected to fill a 250-mL container. All discrete sample

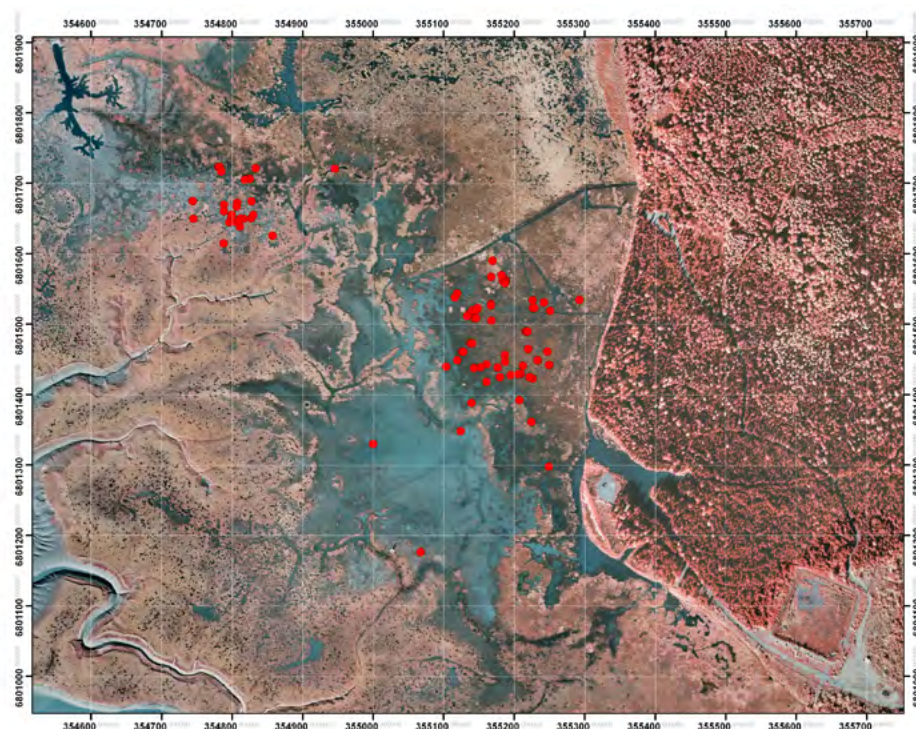
Figure III-2-2. Map of discrete locations in Area C and Area BT that were resampled in 2007 to determine if capping is required.

locations were photographed in May 2007 (Appendix III-2-A); in August 2007, we marked all locations where WP concentrations were still greater than $1 \mu\text{g/g}$ with an orange survey stake for subsequent capping.

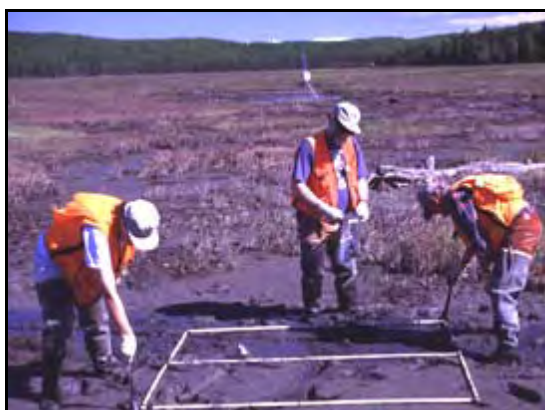
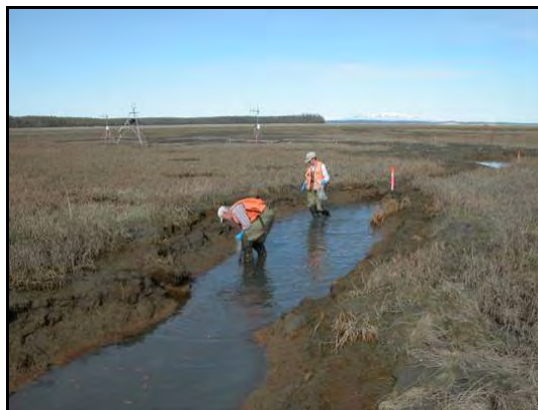
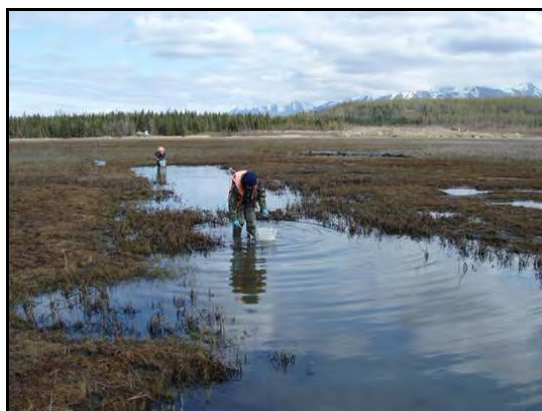
a. 1.82-m square grid (sediment)

b. linear (sediment)

c. sieved (≥ 0.59 -mm size fraction)

The first method (grid multi-increment sampling) was developed in 1996 (Walsh et al. 1997) as an alternative to using penned sentinel ducks to determine if sufficient WP mass was present in a defined area to poison waterfowl. In this method, samples are formed by combining sediment subsamples collected using an Oakfield corer (2-cm diameter) to a depth of 10 cm at the nodes of a 1.82-m-square grid. Spacing of the subsamples is designed to detect 2-m diameter hotspots (Gilbert 1987). Use of a quadrat helps to maintain relatively precise subsample spacing (Fig. III-2-3a). Decision unit grid size is generally around

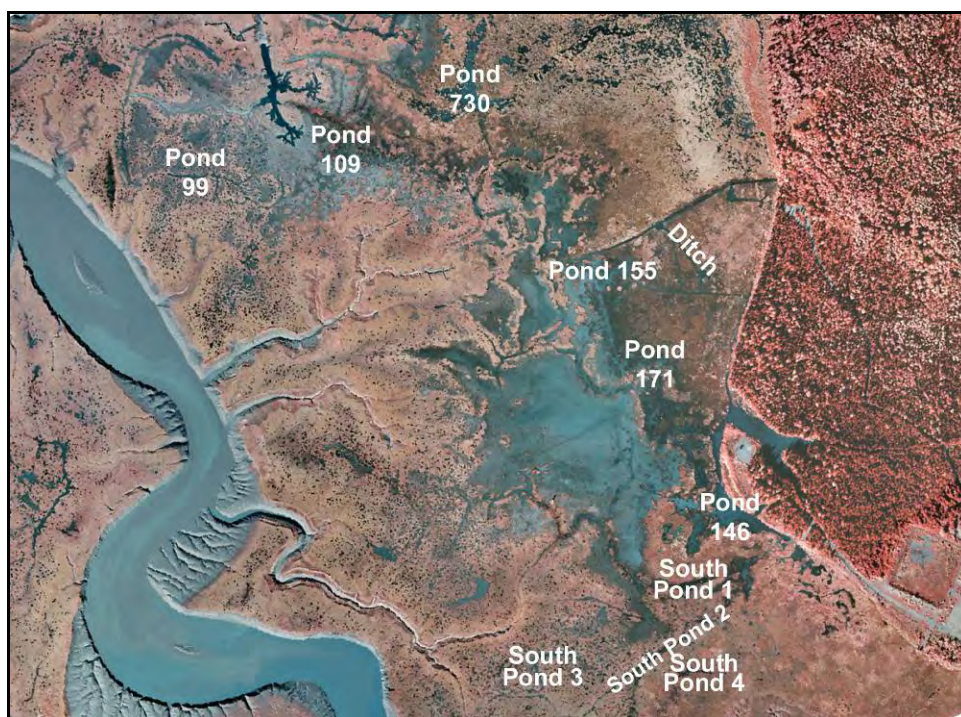
Figure III-2-4. Aerial photograph taken (Aero-Metrics, 2006) showing the identification numbers of ponds where multi-increment samples were collected.

Surveys for metallic scrap were also conducted in Pond 730, in Area C/D (Fig. III-2-4), and in Pond 290 in Area A. These ponds historically have not had detectable WP concentrations, but multiple waterfowl carcasses have been found around each of these ponds. Because of the waterfowl mortality, Pond 290 was pumped during the summer of 1998 and Pond 730 was pumped each summer between 1991 and 2003. Carcasses and feather piles continue to be found around these ponds (Collins et al. Section II-2). In 2007, duplicate sieved multi-increment samples were collected concurrent with the metallic ordnance surveys.

In conjunction with studies for the Environmental Impact Statement for year-round training at Eagle River Flats, multi-increment samples were collected from Ponds 109 and 99 in Area BT (Fig. III-2-4), which had been drained in 1996 by ditching. Details of the studies in support of the Environmental Impact Statement will be presented elsewhere; results for WP analysis are summarized in this report. Briefly, triplicate 100-increment samples were collected from a 200-m x 200-m target area before and after the firing of fourteen 120-mm mortar projectiles into Eagle River Flats on 6 June 2007. The increments were collected using a 3-cm diameter corer to a depth of 2.5 cm. Only three projectiles actually detonated in the targeted area; the others detonated on the mudflat south and southeast of the targeted area. All 14 impact craters were also sampled. One

The last monitoring station was located within the pond complex in the southeast corner of Area BT, known as the Duck Ponds (Fig. III-2-4). These ponds were sampled in 2003 after three Green-winged Teal carcasses were found. Subsequent sampling of the ponds and surrounding marsh in 2003 and 2004 detected several white phosphorus hotspots. Drainage channels and a tide gate were installed in July 2004 to remove as much surface water as possible and remove the ponds as waterfowl habitat between flooding tides.

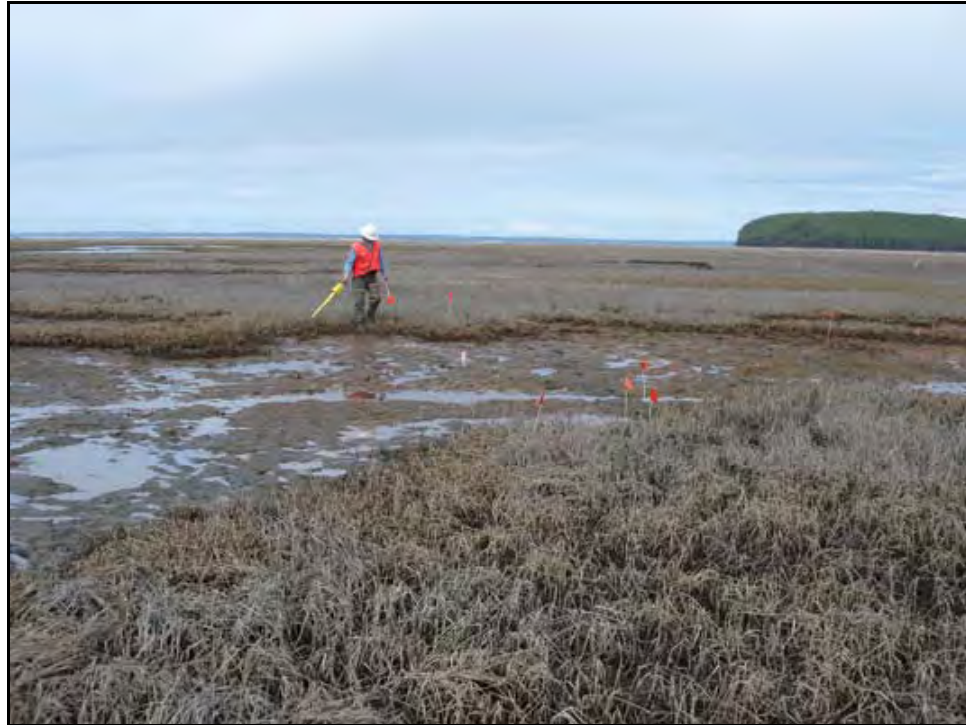
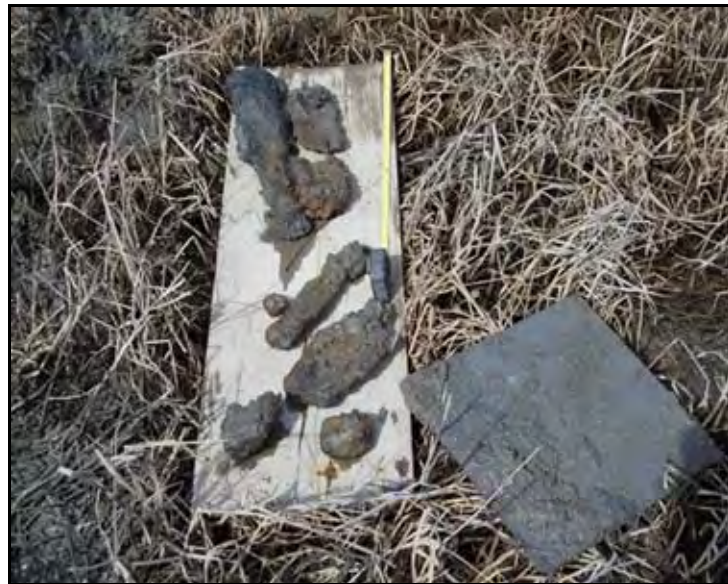
Figure III-2-5. Survey of Pond 155 for metallic scrap in May 2007.

a. Survey for metallic debris.

b. Ordnance scrap removed from the sediment.

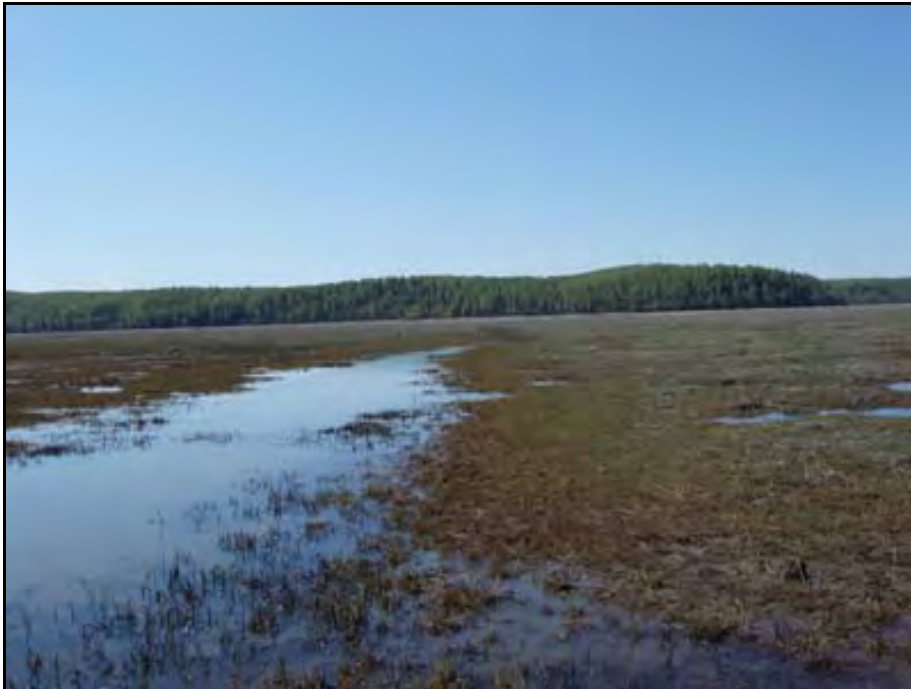
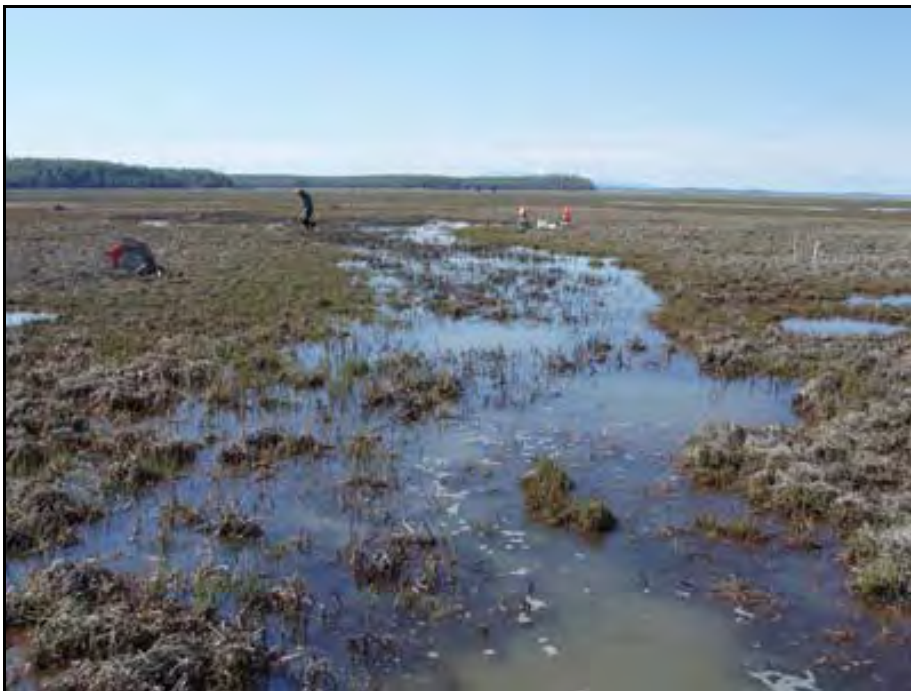
Figure III-2-6. Images (May 2007) of shallow ponds in southern Area C.

a. South Pond 2 (with feeding Northern Shovelers).

b. South Pond 4.

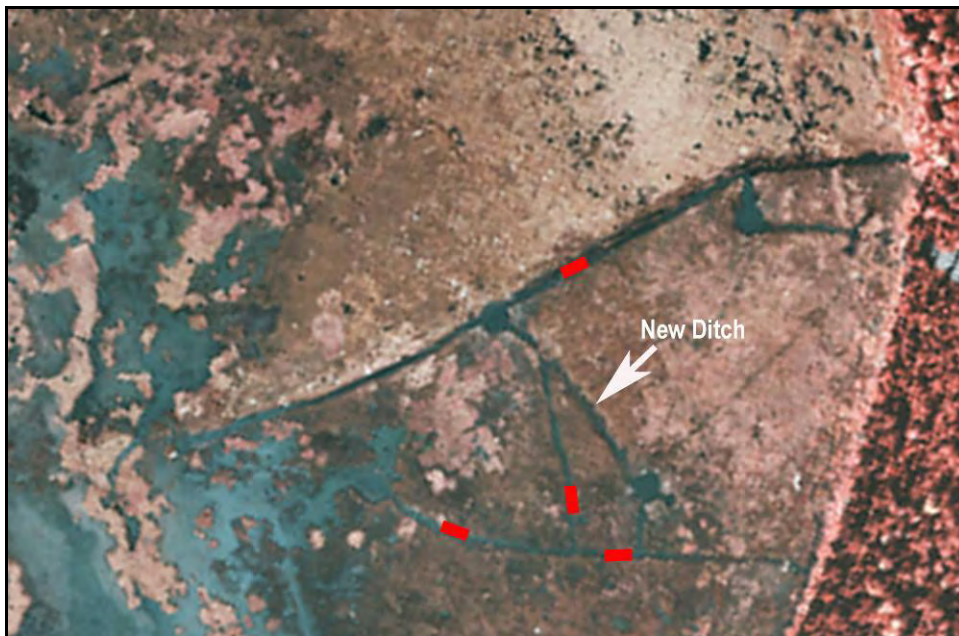
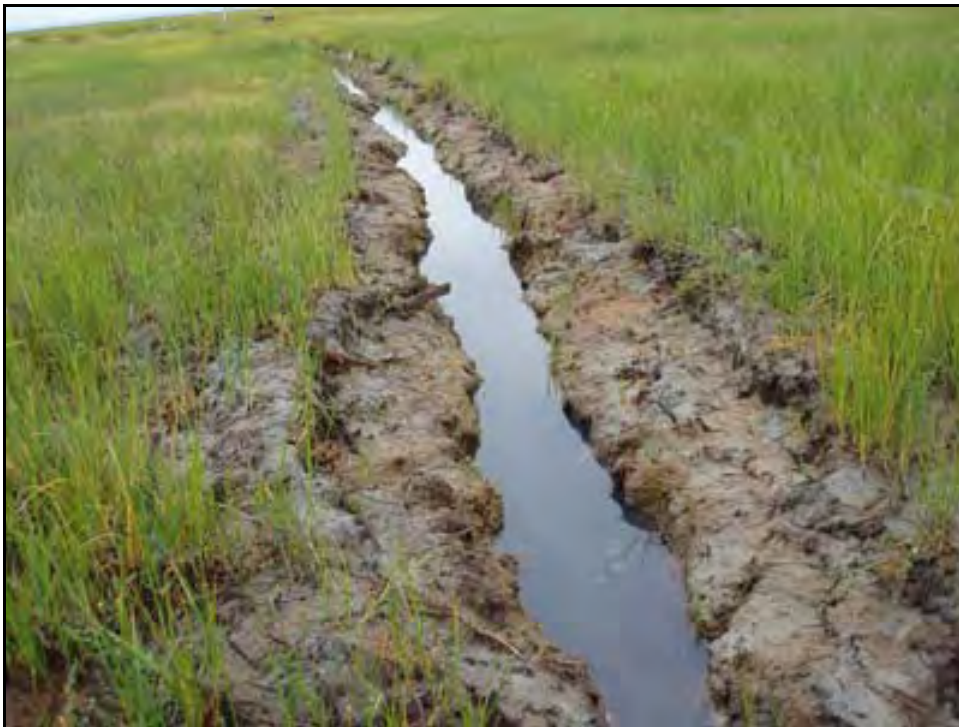
Figure III-2-7. Drainage ditches in C Marsh

a. Ditch sections (red rectangles, 5-m-long) where particulate WP was detected in 2006.

b. Ground view of new ditch blasted in 2006.
